SIM 61 01 23

SERVICE ACTION: (12V) BATTERY BOX COVER REPLACEMENT

| E-Series | Model Description | Production Date |
|---|---|---|
| F56 | MINI Cooper SE Hardtop 2 Door Battery Electric Vehicle (BEV) | October 7, 2020 – April 1, 2021 |

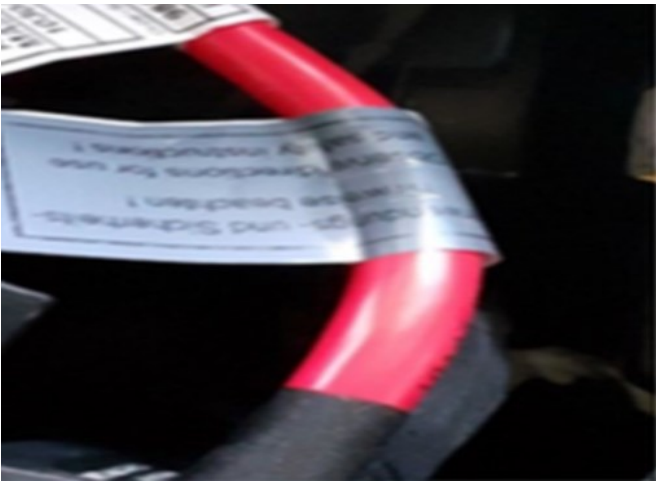
1. No Damage

| Degree of damage | Replacement of battery box cover | Replace the positive battery cable |
|---|---|---|
| Example 1/2/3/4 | Replace | --- |

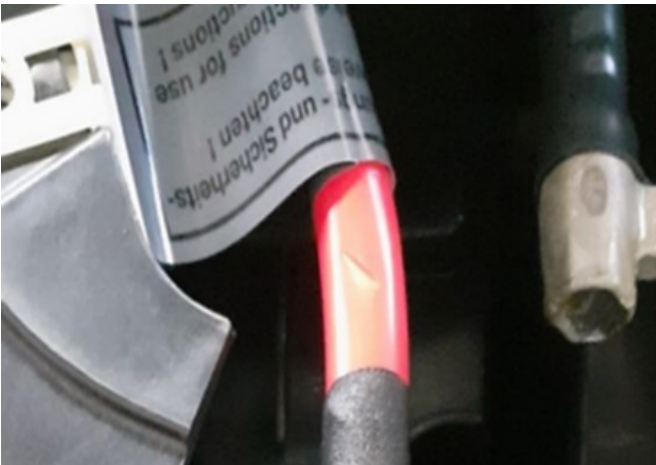
2. Slight Dent without abrasion.

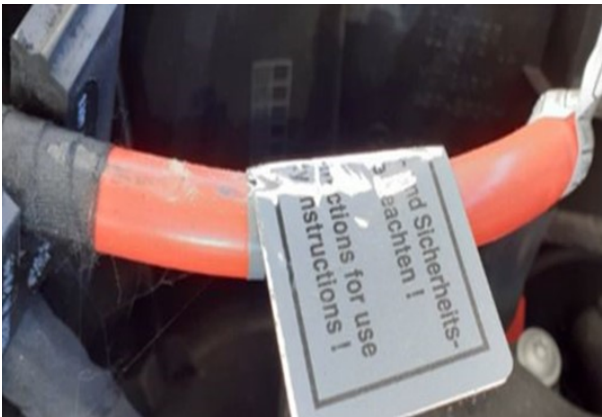
3. Abrasion can be detected on a large area.

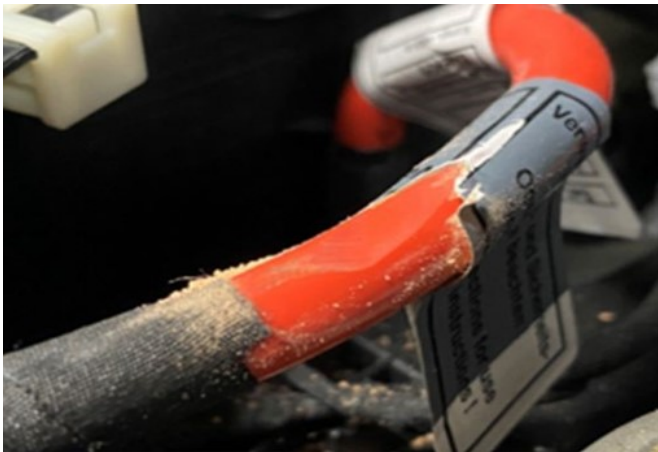
4. Abrasion on large area deep notch.

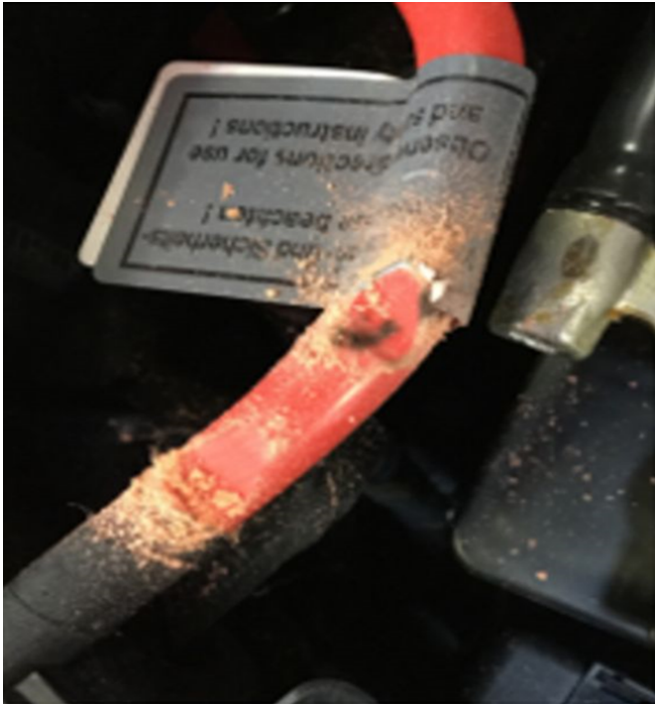
5. Extreme dent on a large area.

A. If necessary, replace the positive (+) battery cable. Follow the repair instructions **REP 61 12 001 “Replace positive battery cable”**.

| Degree of damage | Replacement of battery box cover | Replace the positive battery cable |
|---|---|---|
| Example 5 | Replace | Replace |
